# Good Work Practice

## Leaking Drum Identified, Contained in Safe and Efficient Manner

March 19, 2007

2007-RL-HNF-0012

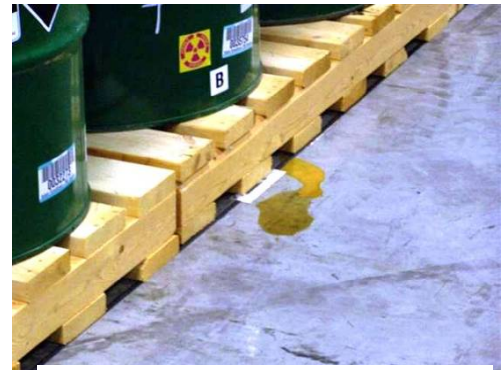
On March 7, 2007, while performing surveillance, a Nuclear Chemical Operator noticed a small puddle of rust-colored liquid adjacent to a pallet of drums stored in the Central Waste Complex storage facility. The liquid had not been observed during the previous day's surveillance. Assuming he may have stepped in the liquid, the operator removed his shoes, remained in place, and called a Radiological Control Technician (RCT). The RCT performed a survey and found a non-reportable quantity of radiological contamination (24,000 dpm/100cm<sup>2</sup> beta/gamma, no alpha) on one shoe. Personnel were surveyed out of the building.

Photo of Identified Leakage

The Operations Manager staffed the Incident Command Post (ICP) to address a possible hazardous waste spill. A recovery plan was developed to allow personnel to enter the building with appropriate Personnel Protective Equipment (PPE), in order to sample the material, mitigate the spill, and determine the source.

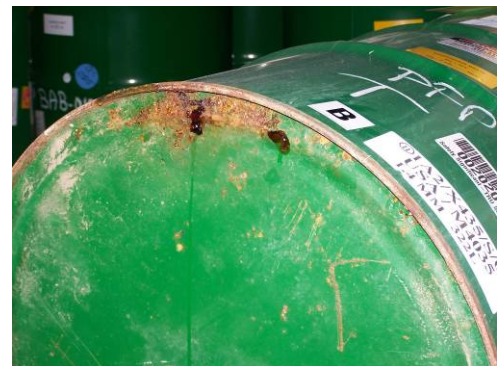
Pinholes on Bottom of 85 Gallon Overpack

Contamination and airborne surveys were conducted. The liquid had leaked from an overpacked waste drum (85 gallon outer drum) located on the bottom tier of a storage array. Sampling of the released liquid indicated an acid constituent (pH of 2). The spill was cleaned up and treated with an acid kit. Follow-up surveys found no additional contamination on the floor and personnel departed the building.

A recovery effort to contain the drum was initiated. Adjacent pallets and waste containers were moved away from the drum and no contamination was found. When tipped, corrosion was noted on the bottom of the overpack. The drum was bagged in plastic wrap with acid neutralizer and placed on a spill pallet. No further abnormal conditions were identified.

The inner 55 gallon container had been sent to the Low Level Burial Grounds in the 1970's, and had been retrieved in 2004. The overpack had been transferred to CWC in 2006. The leaking drum contained room waste from the Plutonium Finishing Plant. A review of the documented history provided no unique characteristics which would have contributed to the corrosion of the overpack drum. Waste Stabilization and Disposition is continuing to investigate this issue.

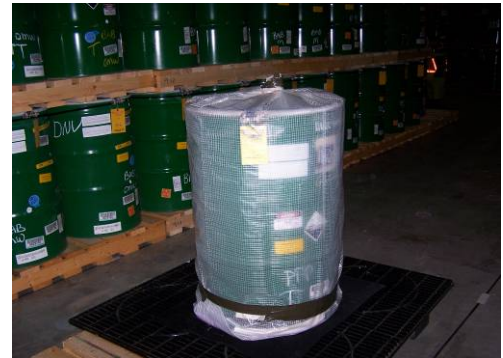
**Photo of Remediated Drum**
